**MUNICIPAL CORPORATION OF GREATER MUMBAI**

**Report of Technical Investigation Committee**  
**regarding the collapse of Compound wall**  
**at Malad Hill Reservoir on 2.7.2019.**

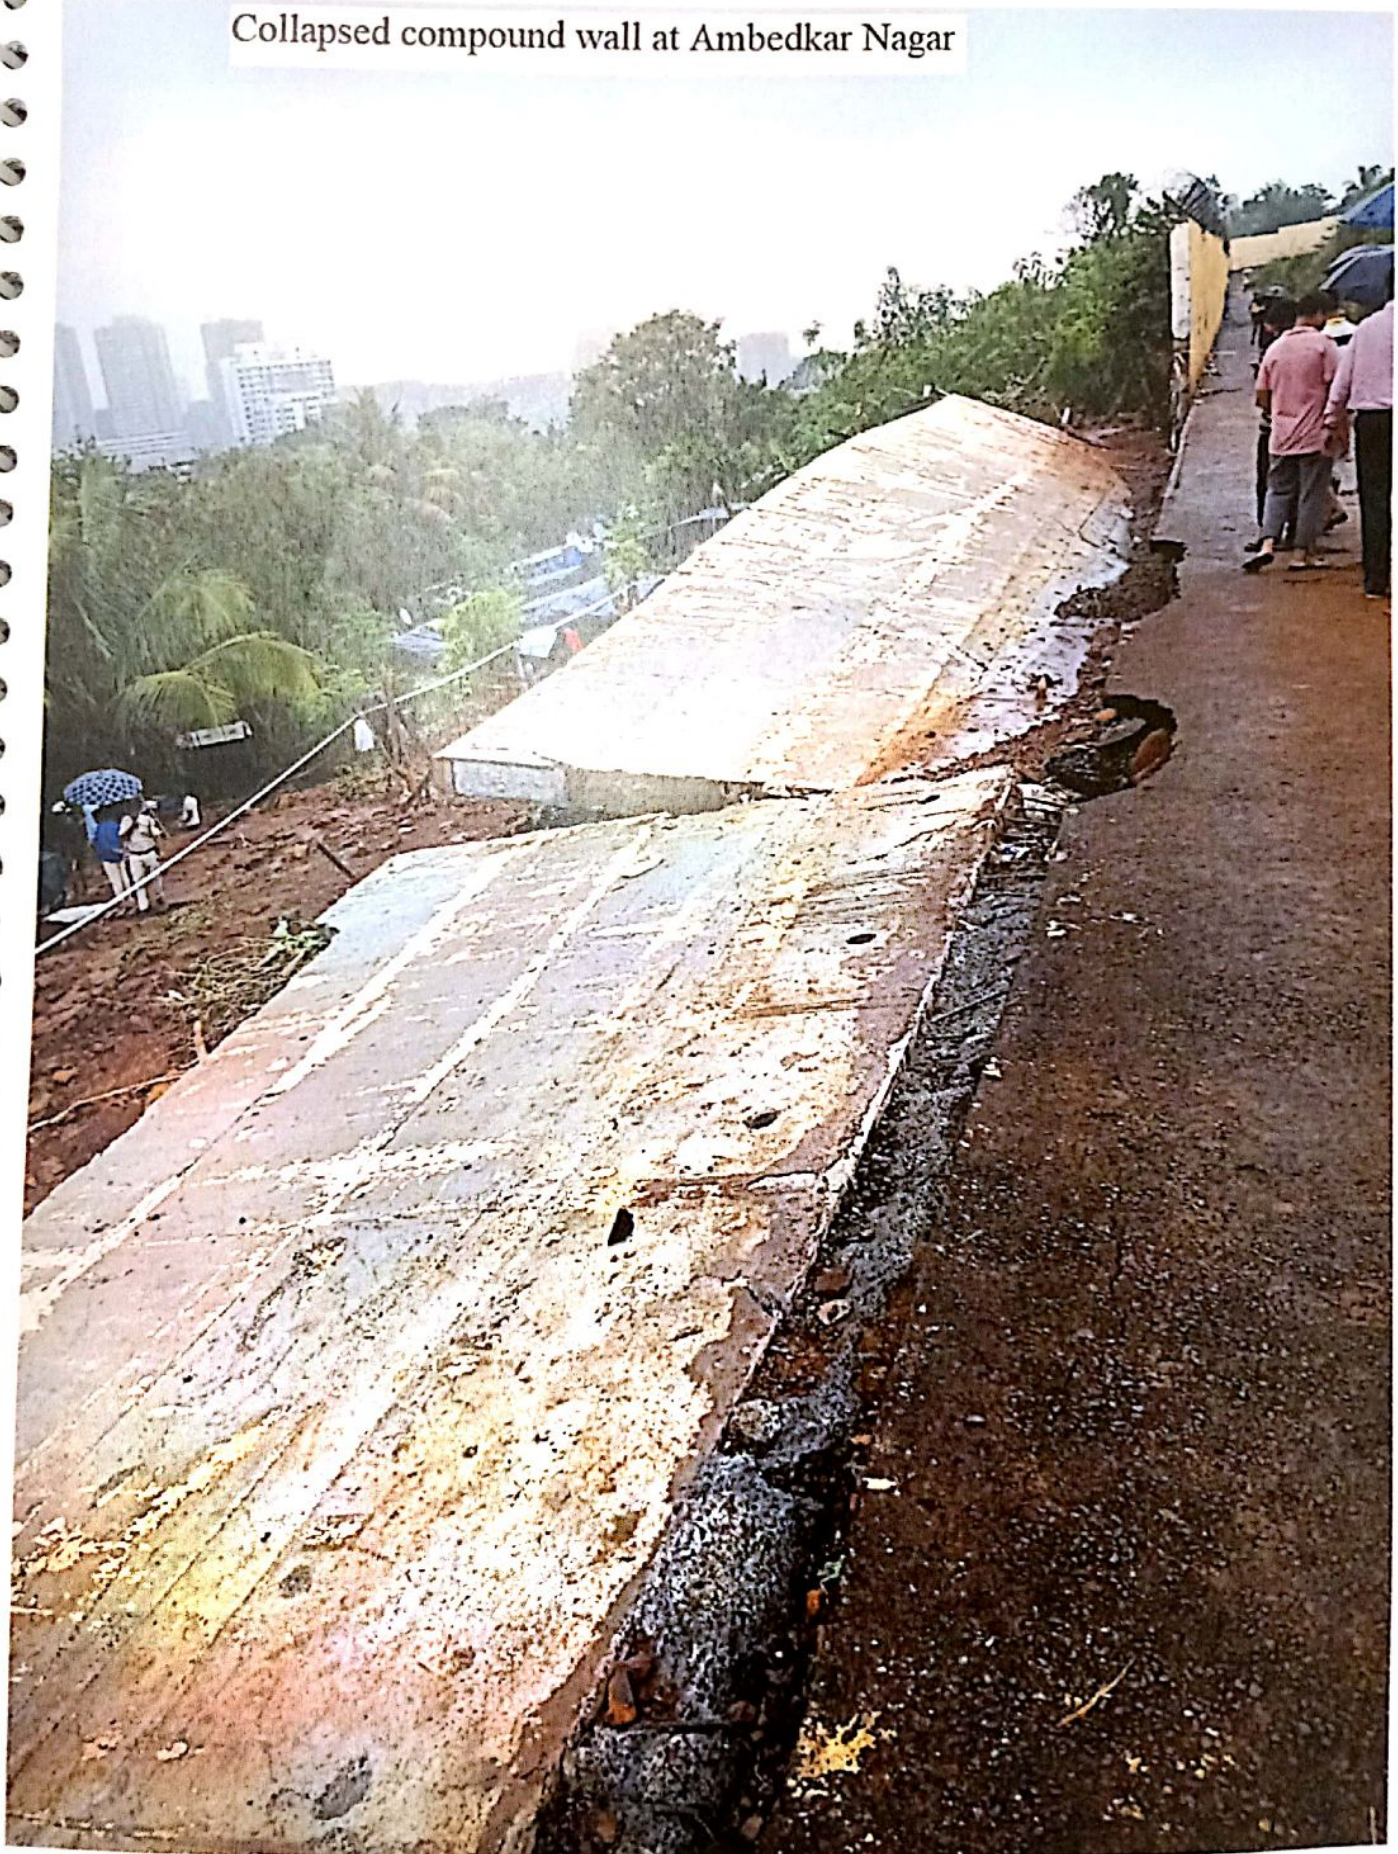
Collapsed compound wall at Ambedkar Nagar

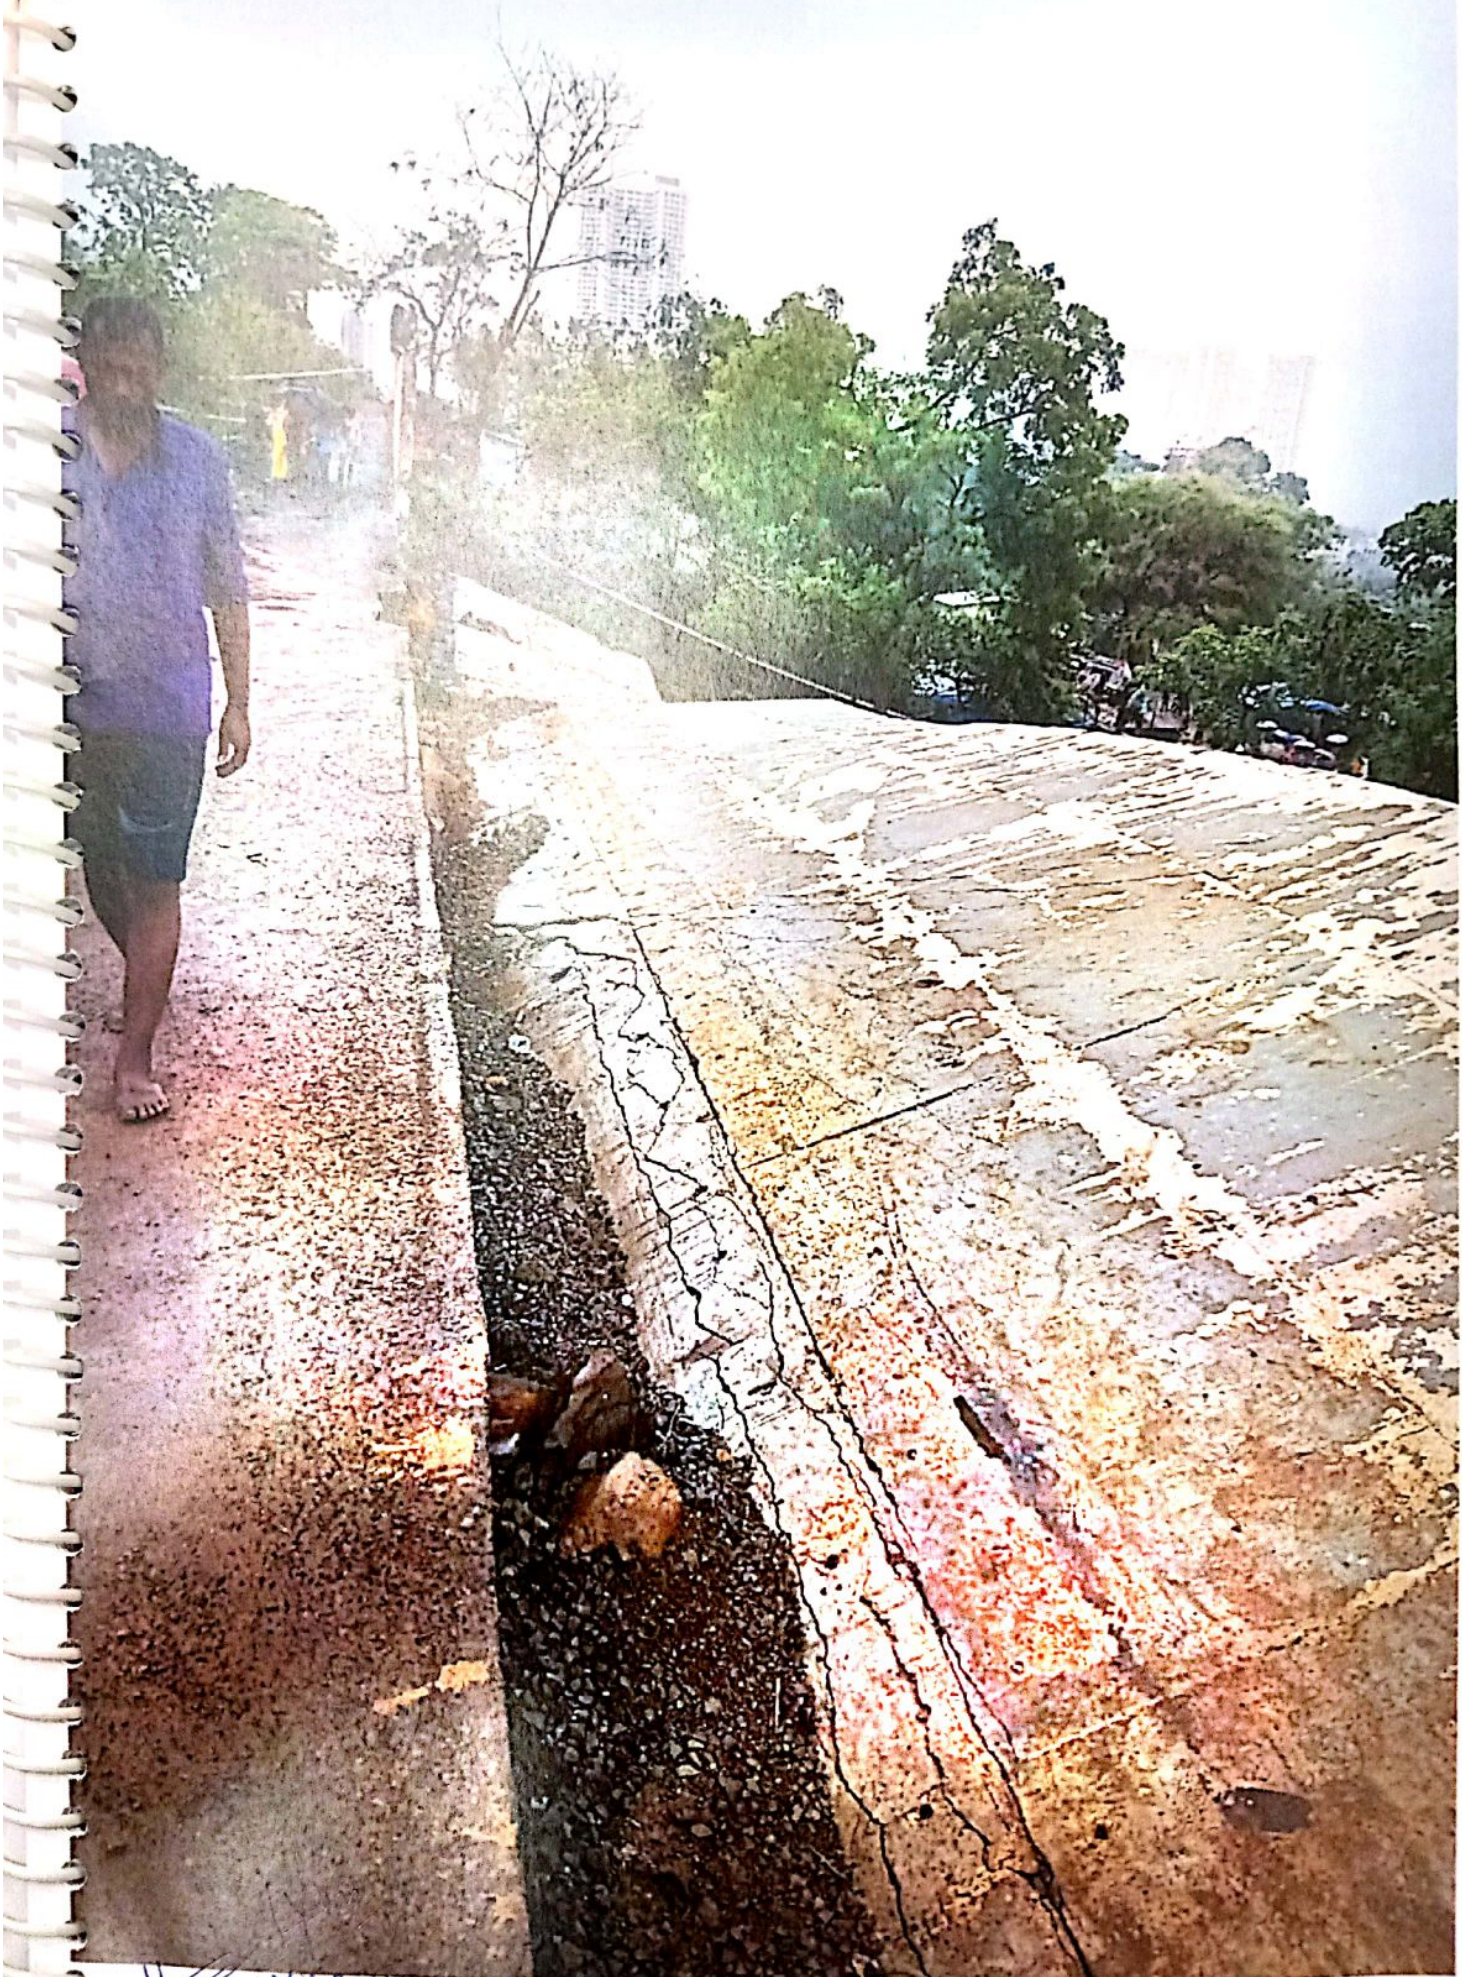
Collapsed compound wall at Ambedkar Nagar

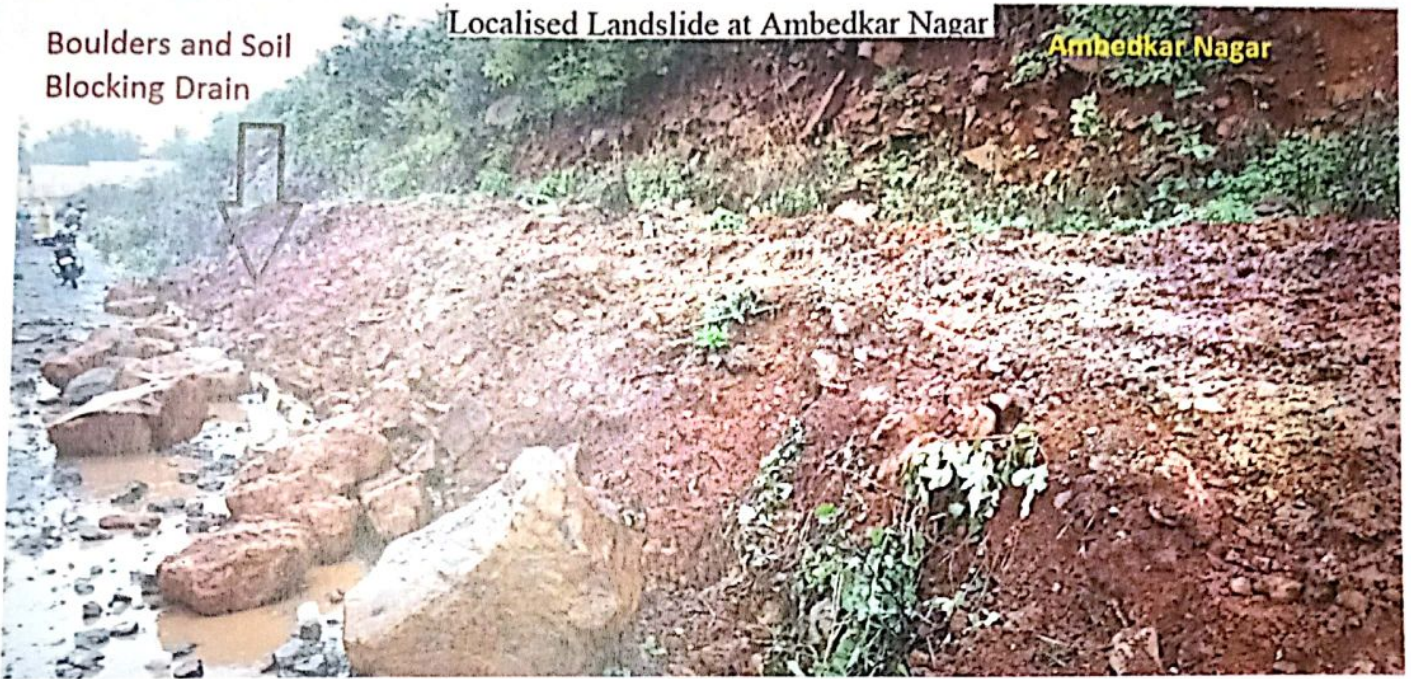
Boulders and Soil  
Blocking Drain

Localised Landslide at Ambedkar Nagar

3. The existing side drains were inadequate to drain out the water from the continuous and heavy rainfall that had occurred during the above mentioned period. Additionally, the localised landslide caused partial blockage of drains worsening the situation further.

1. At Malad Hill Reservoir site, on the upstream side of the storm water drain, the slope should be properly stabilized to avoid any localised landslide.
2. The topography of the plots / properties owned by the MCGM shall be ascertained by the concerned department and if required, slope stabilization shall be carried out to avoid any mishap.
3. The MCGM empanelled Consultant appointed for any work shall be solely responsible for all the design parameters / design aspects and calculations submitted by him/her to the Engineer-in-charge of the work. Further, a condition to that effect shall be incorporated in the respective tender documents. Also, for critical structures and structures on hilly area, the design submitted by the consultant shall be vetted by any prestigious educational institute, such as VJTI, SPCE or IIT Bombay.

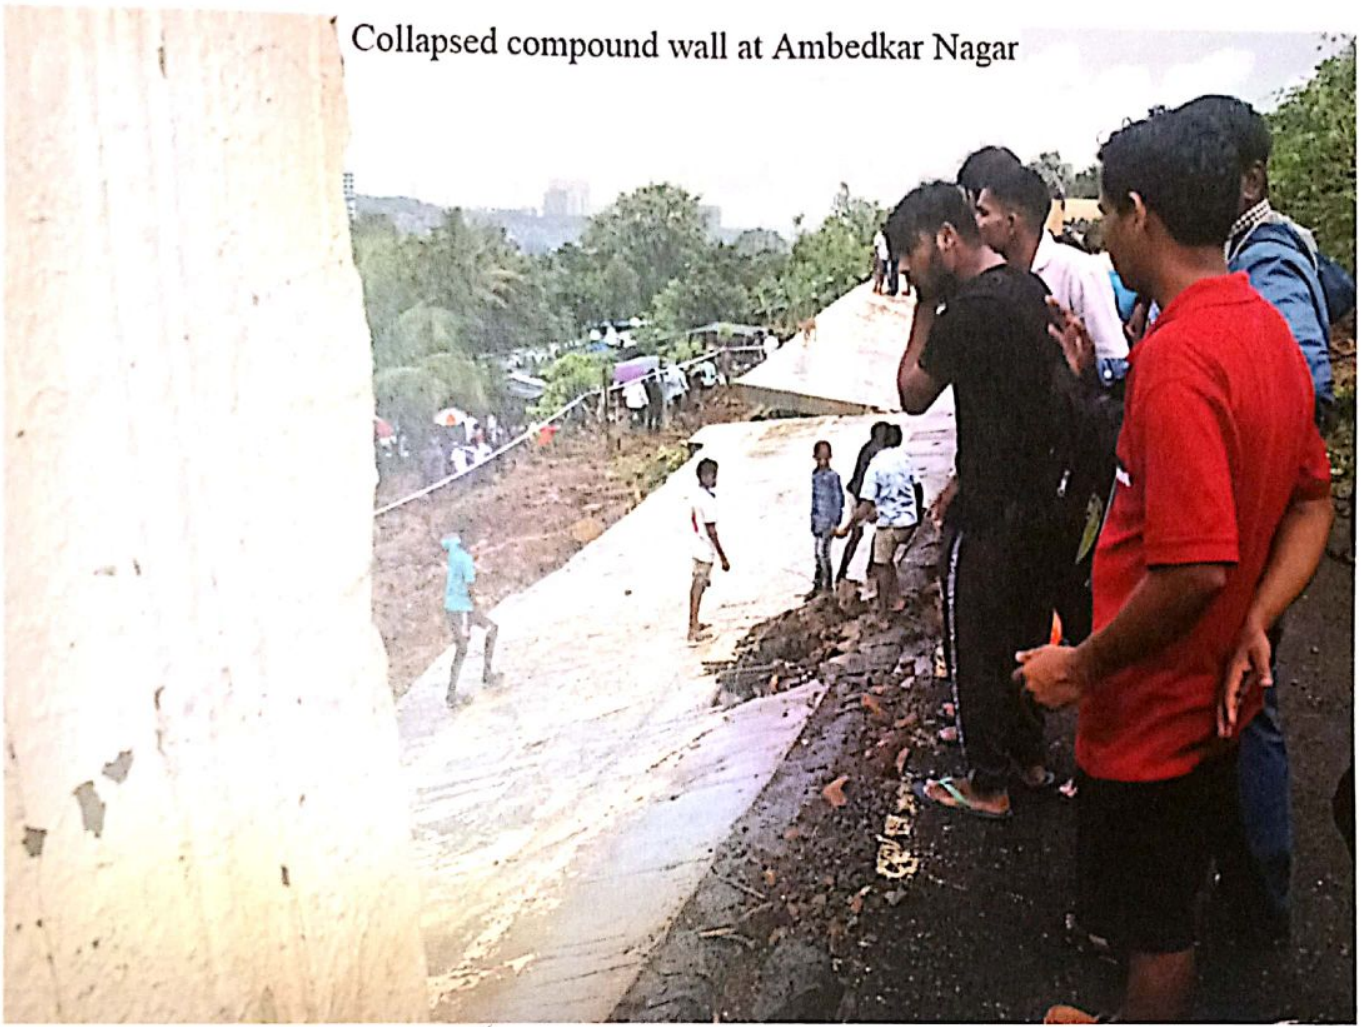
Collapsed compound wall at Ambedkar Nagar

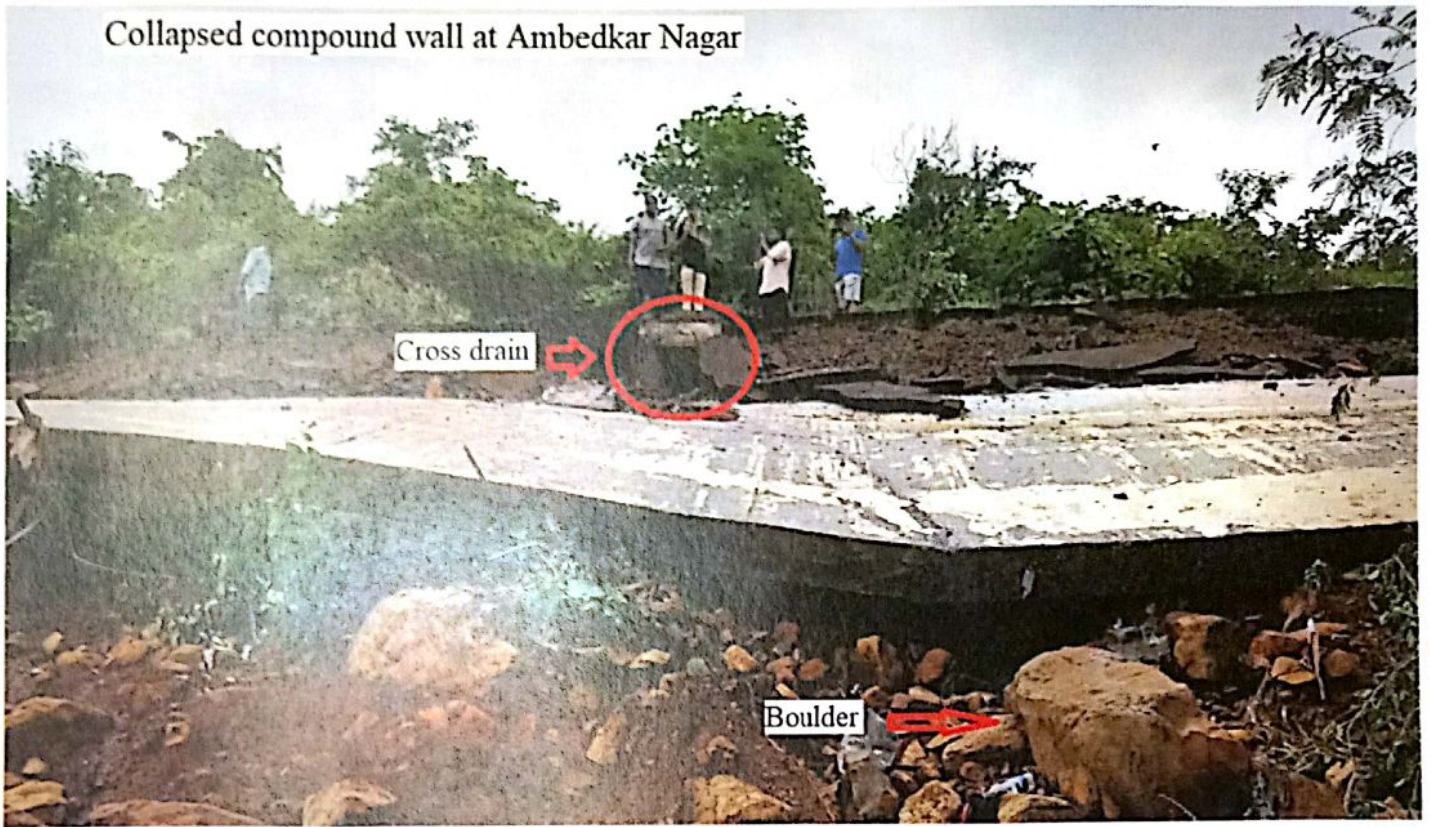
Collapsed compound wall at Ambedkar Nagar

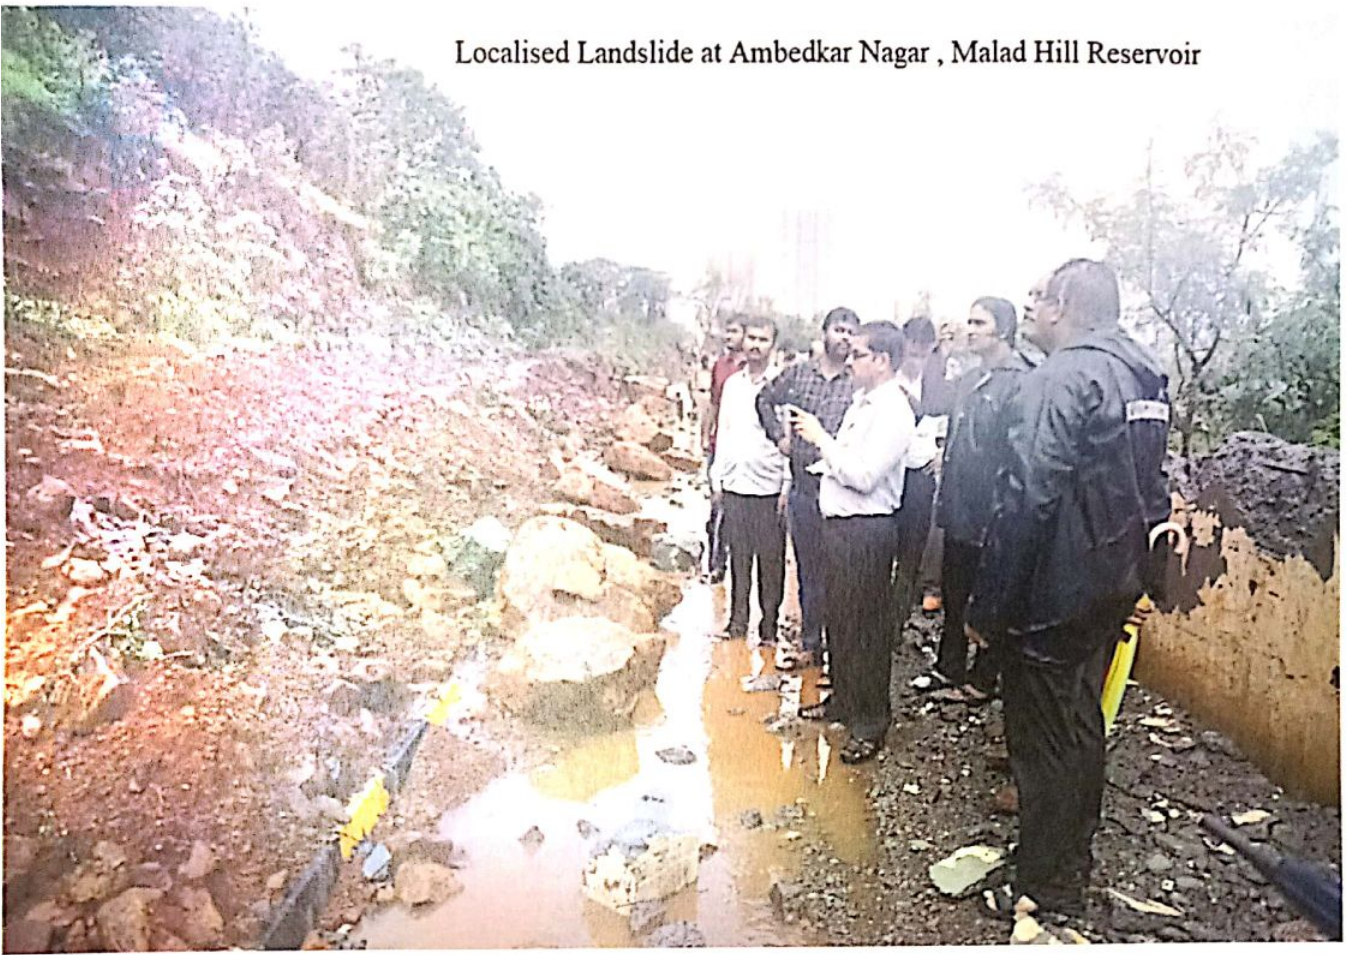
Localised Landslide at Ambedkar Nagar , Malad Hill Reservoir

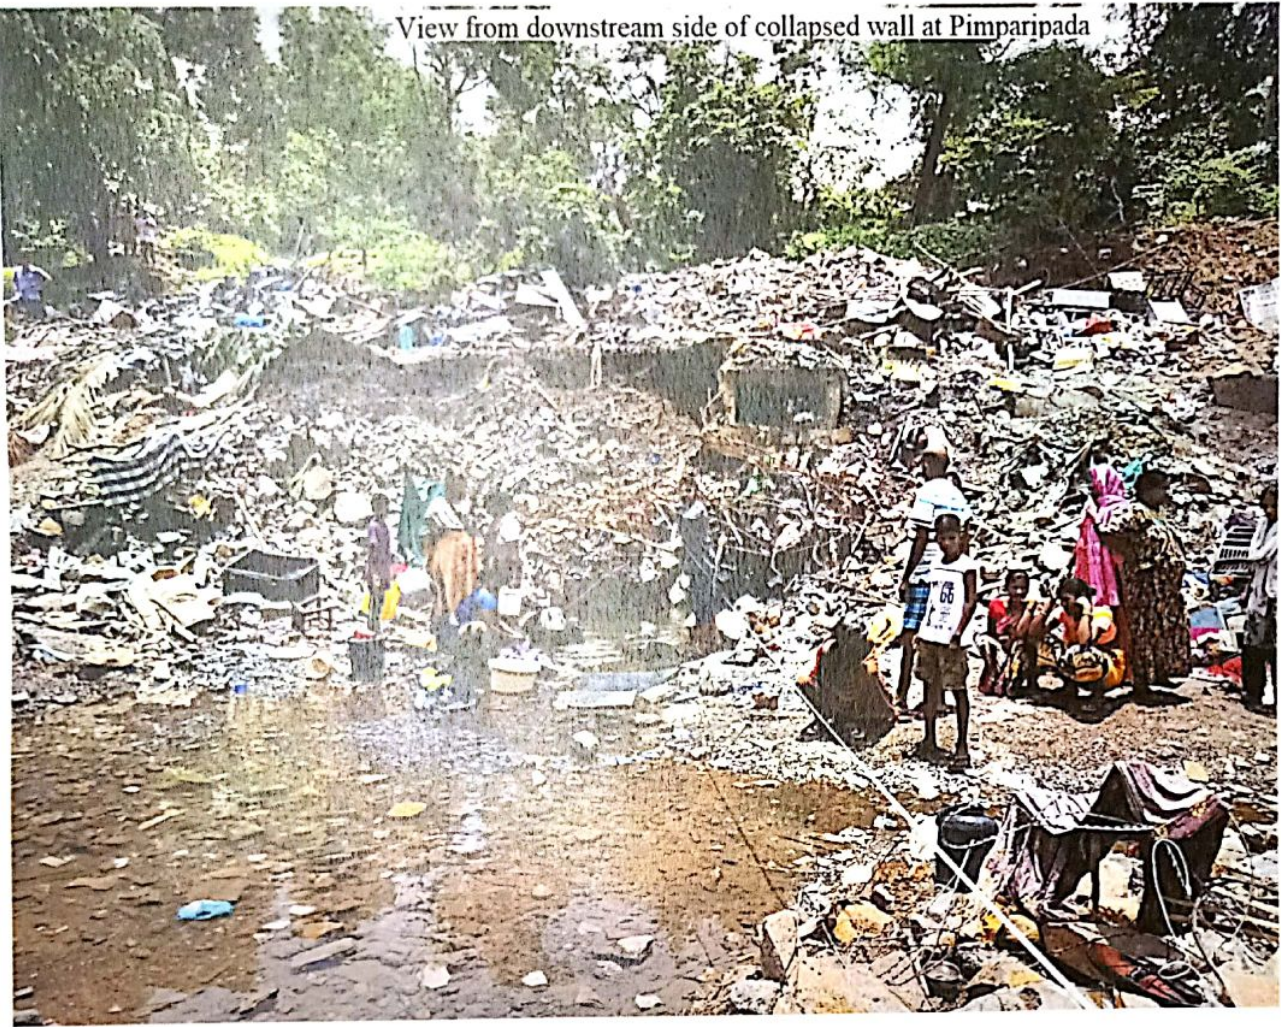
View from downstream side of collapsed wall at Pimparipada

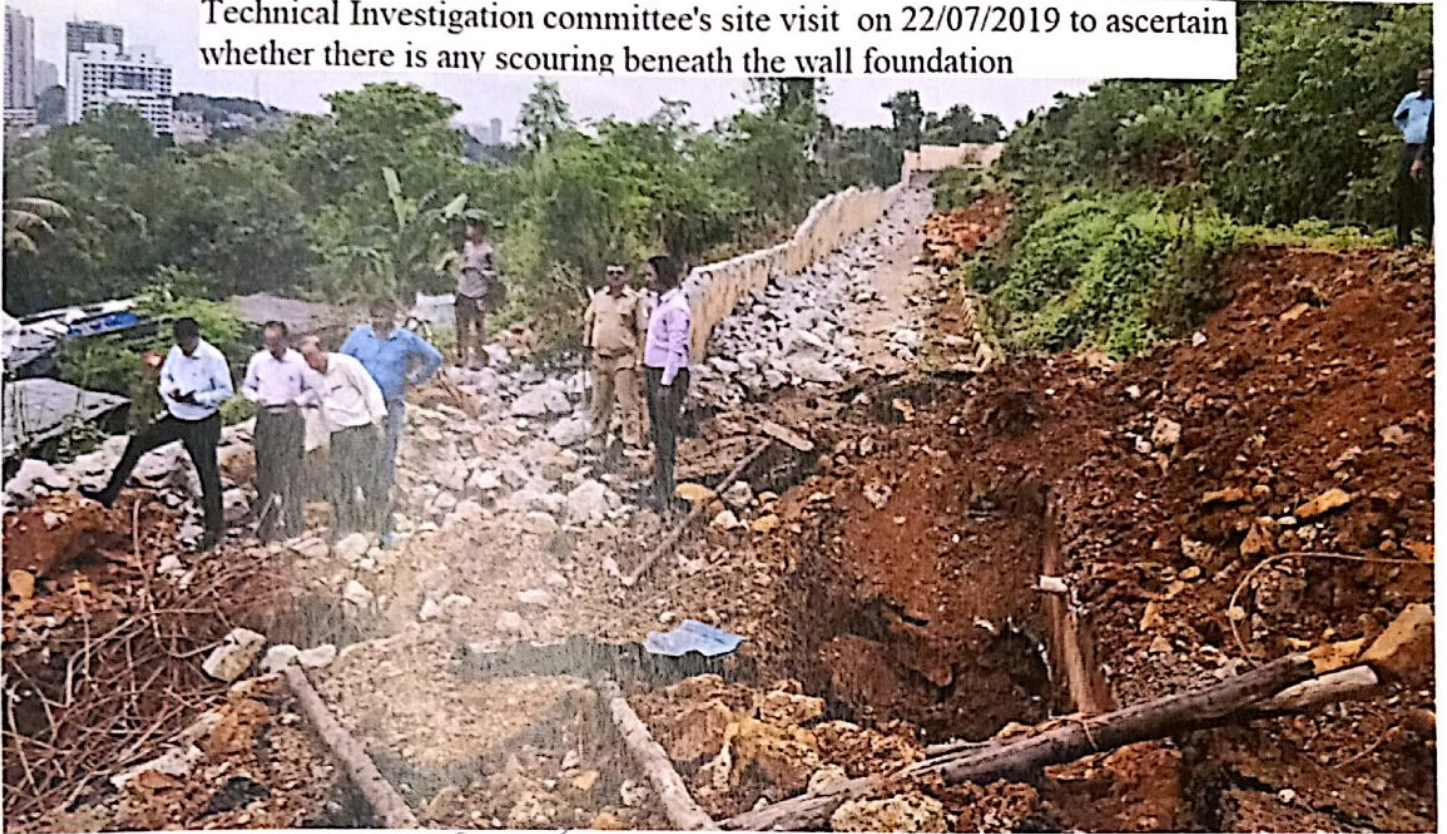
Technical Investigation committee's site visit on 22/07/2019 to ascertain whether there is any scouring beneath the wall foundation

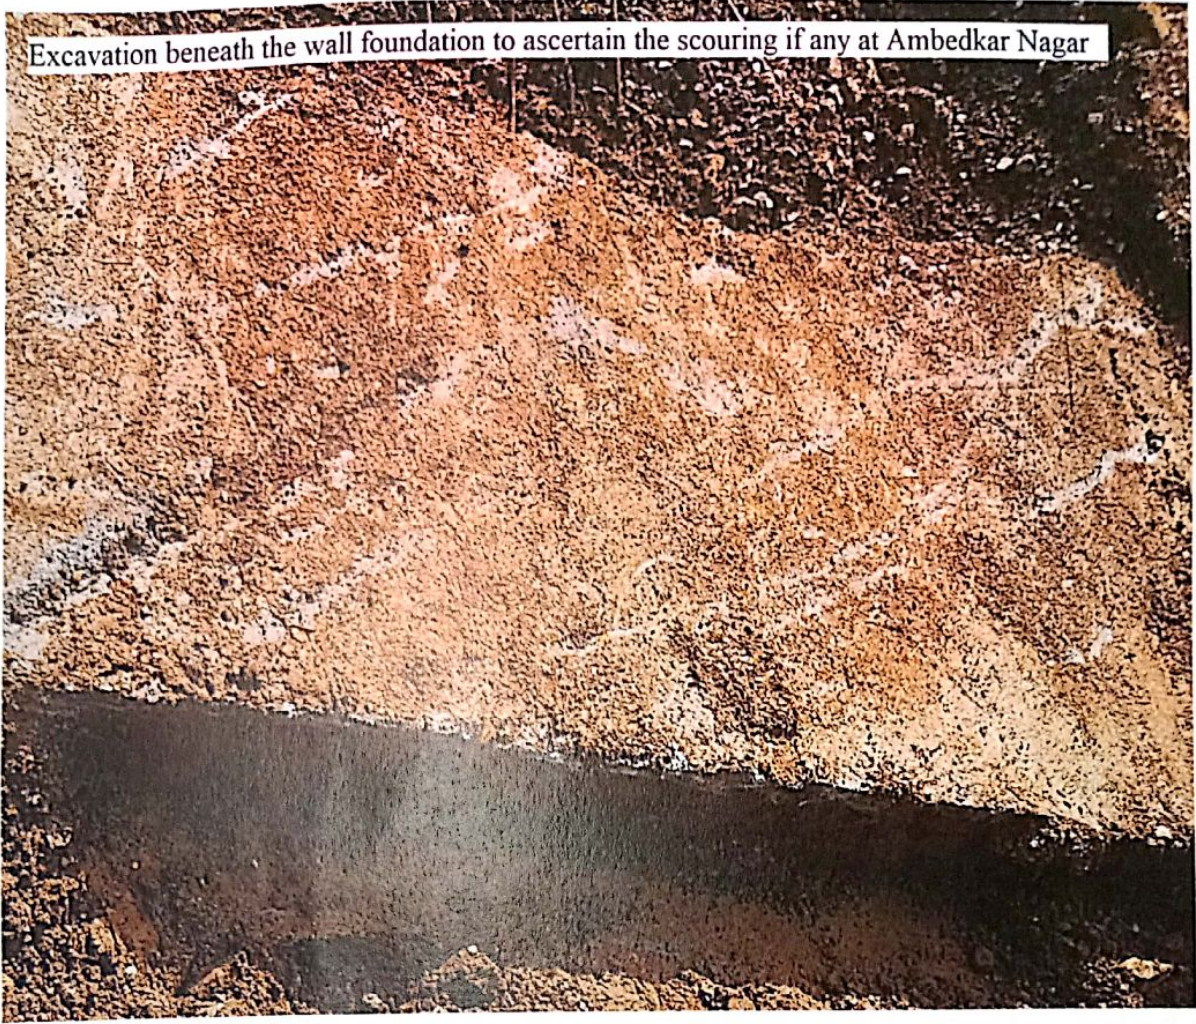
foundation at both the locations and it was observed that there was no scouring beneath the foundation. Then the Committee members witnessed all the cores properly stacked in the MCGM office at Malad Hill Reservoir. Prof. G.B.Chaudhari then suggested to send these cores to IIT Bombay for testing and further informed that he would like to be present during the testing of these cores.

Excavation beneath the wall foundation to ascertain the scouring if any at Ambedkar Nagar

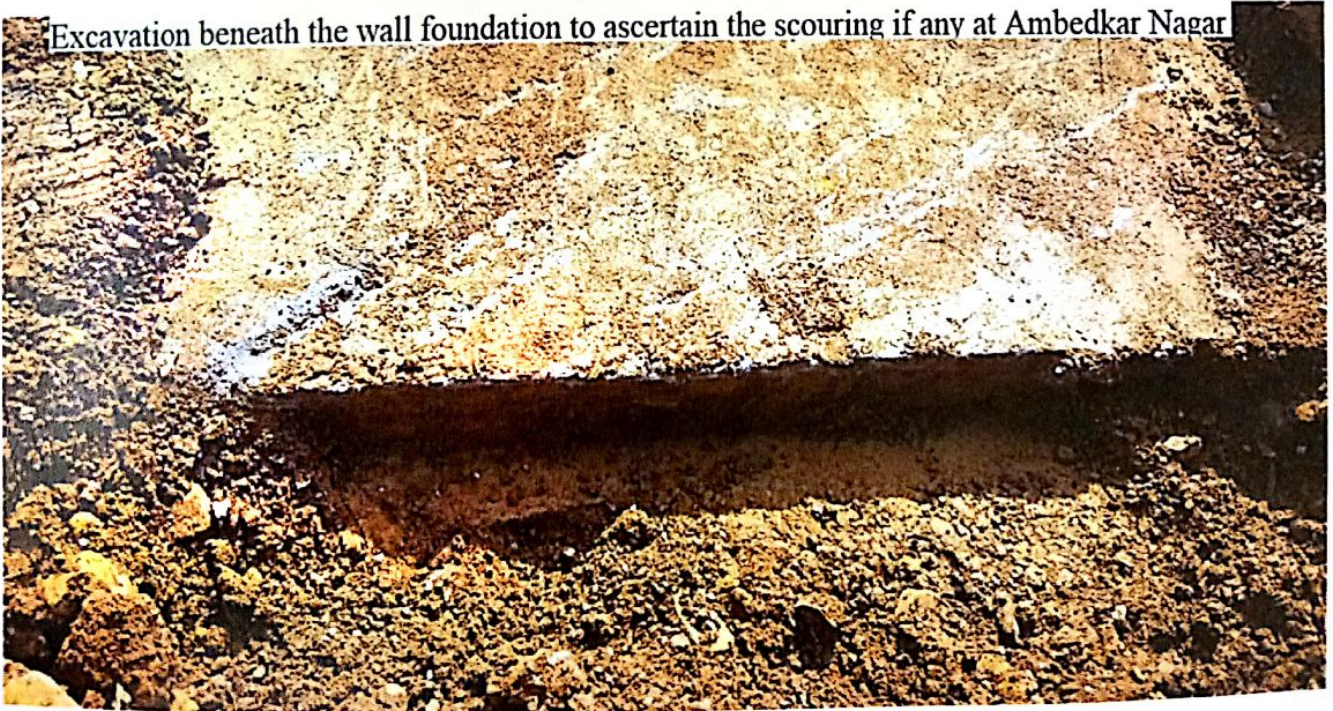
Excavation beneath the wall foundation to ascertain the scouring if any at Ambedkar Nagar

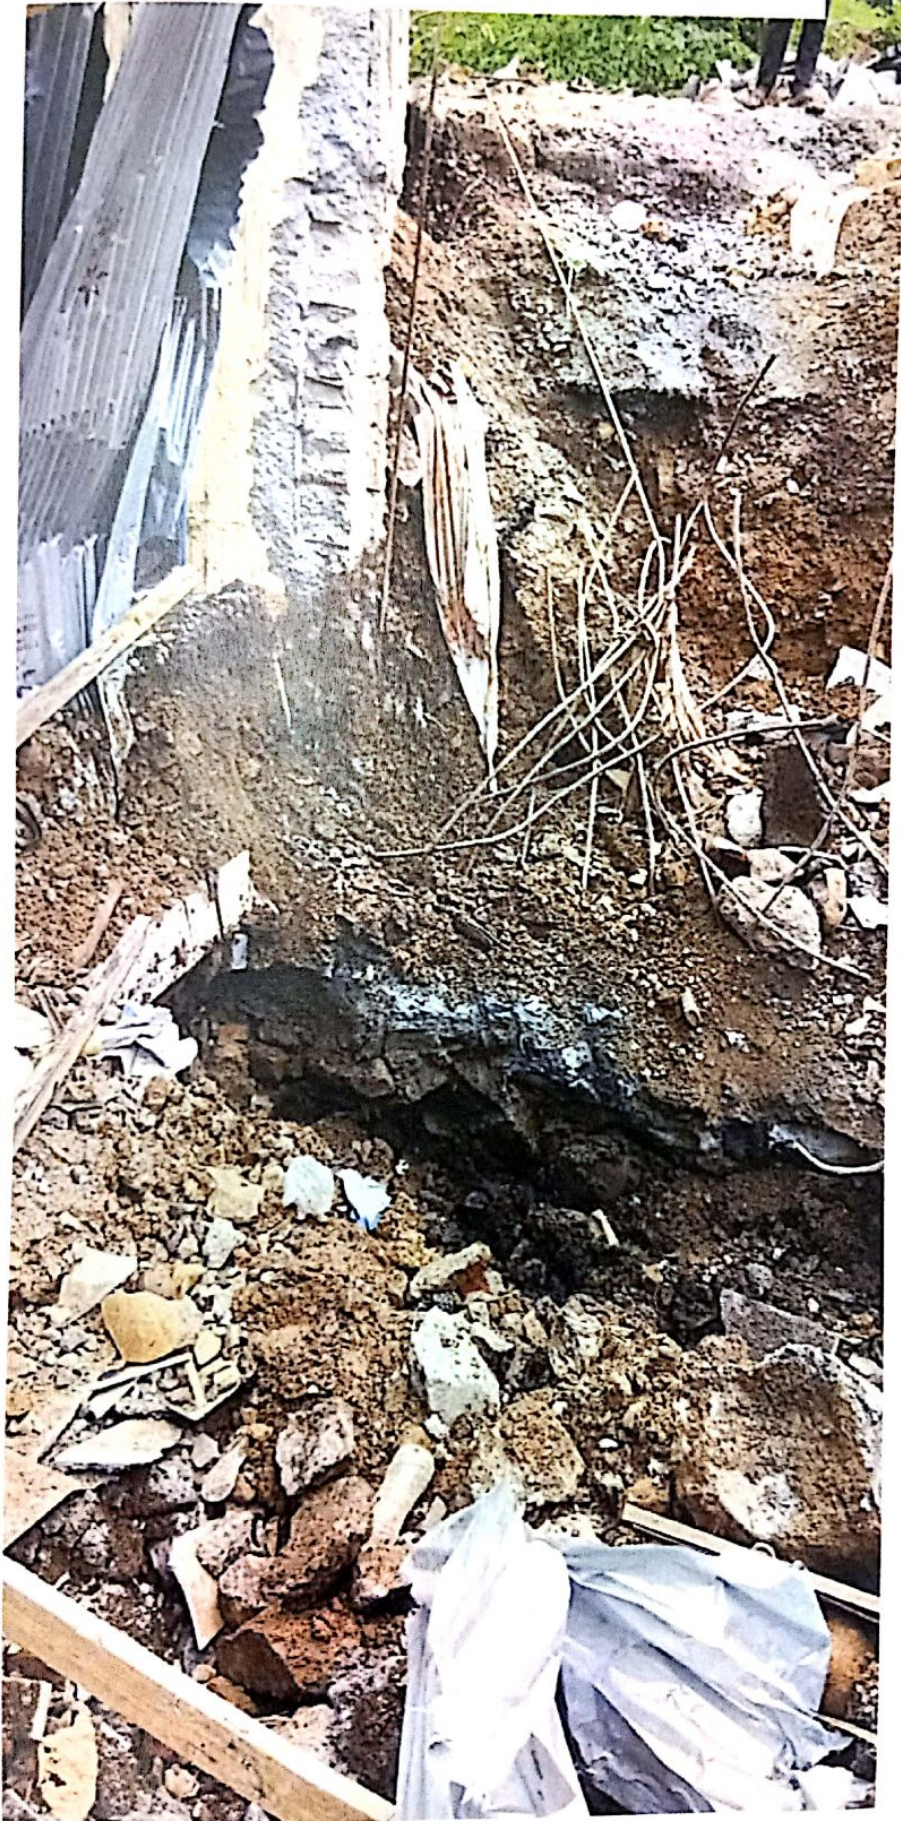
Excavation beneath the wall foundation to ascertain the scouring if any at Pimripada

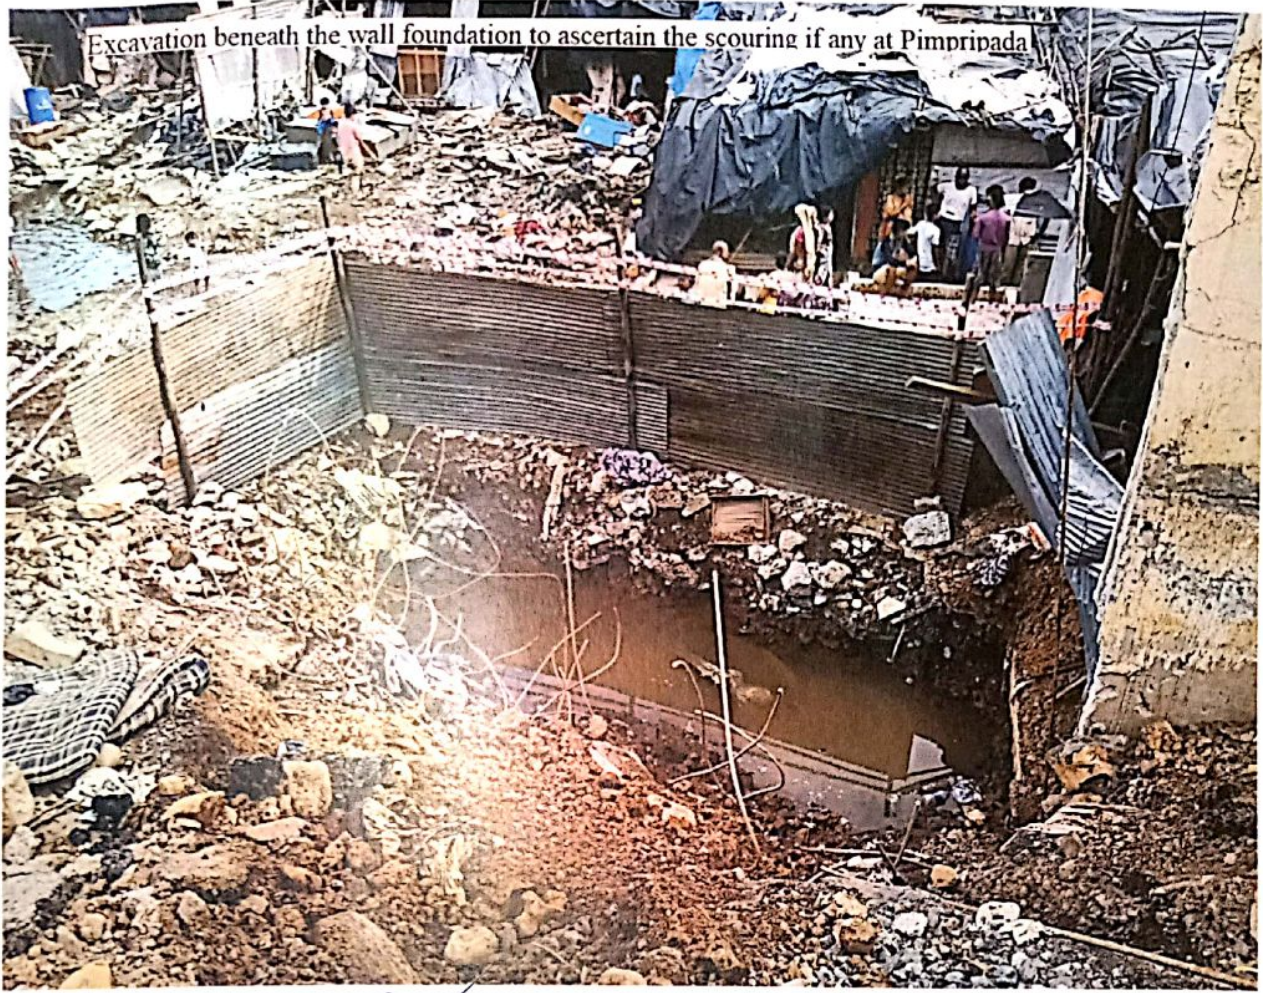
Excavation beneath the wall foundation to ascertain the scouring if any at Pimpripada
