**ENQUIRY REPORT ON THE
INCIDENT OF DEMISE OF
DR. AMARAPURKAR DUE TO
FALLING IN S.W.D. MANHOLE
ON 29.08.2017**

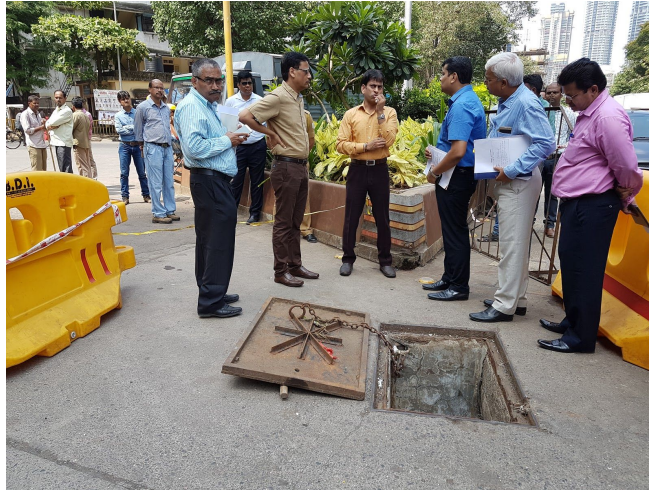
6.2.2.3 Photos showing manhole at incident location visited by Enquiry Committee along with Assistant Commissioner G/South Ward and SWD Officials

(In photo below: The Enquiry Committee along with Assistant Commissioner G/South Ward and SWD Officials visited the incident spot on 06.09.2017 to understand as to how the incident could have occurred.)

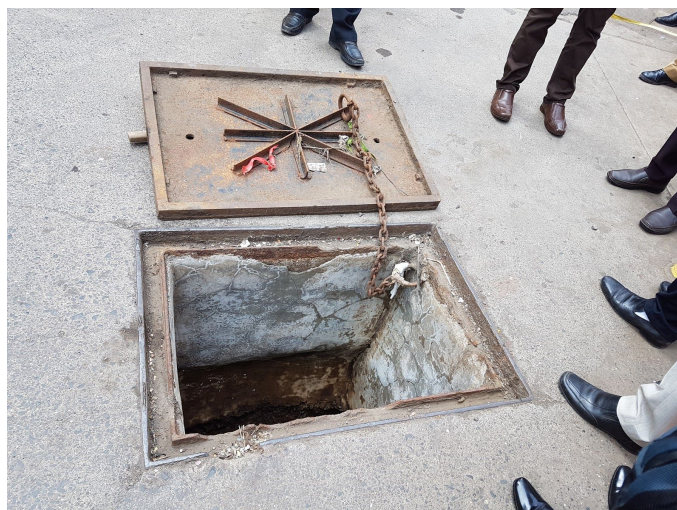
A second photo in closeup position shows the incident manhole in open condition, wherein it can be seen that the manhole cover is chained to the manhole chamber with iron/steel chain so as to avoid theft.

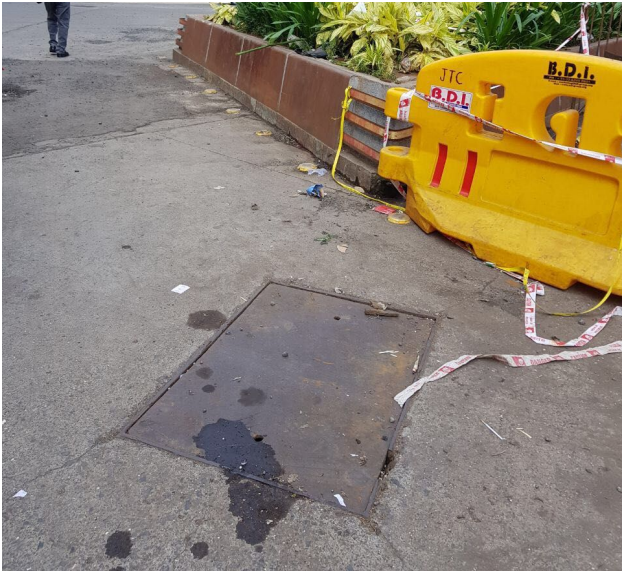
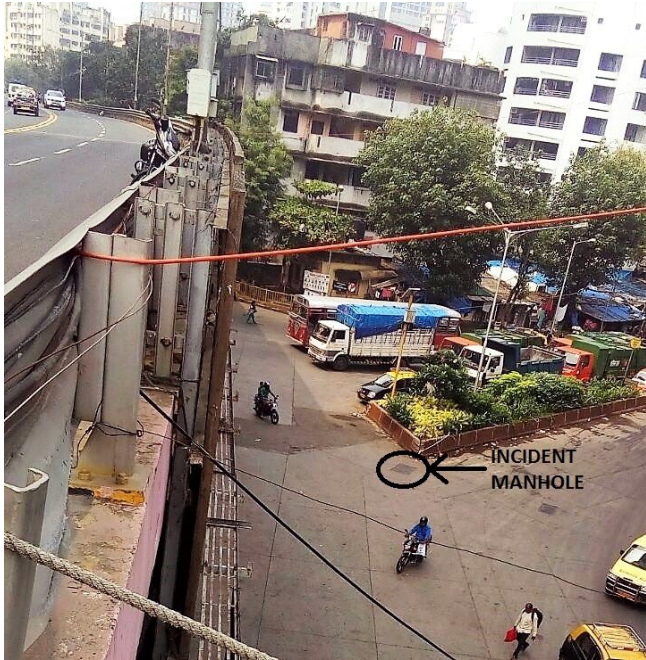
6.2.2.4 Photo of manhole at incident location and a photo taken from bridge

The photo shows the incident manhole in closed position nearby the traffic island while a photo taken from bridge showing the exact location of the incident manhole corresponding to the traffic island and bridge.

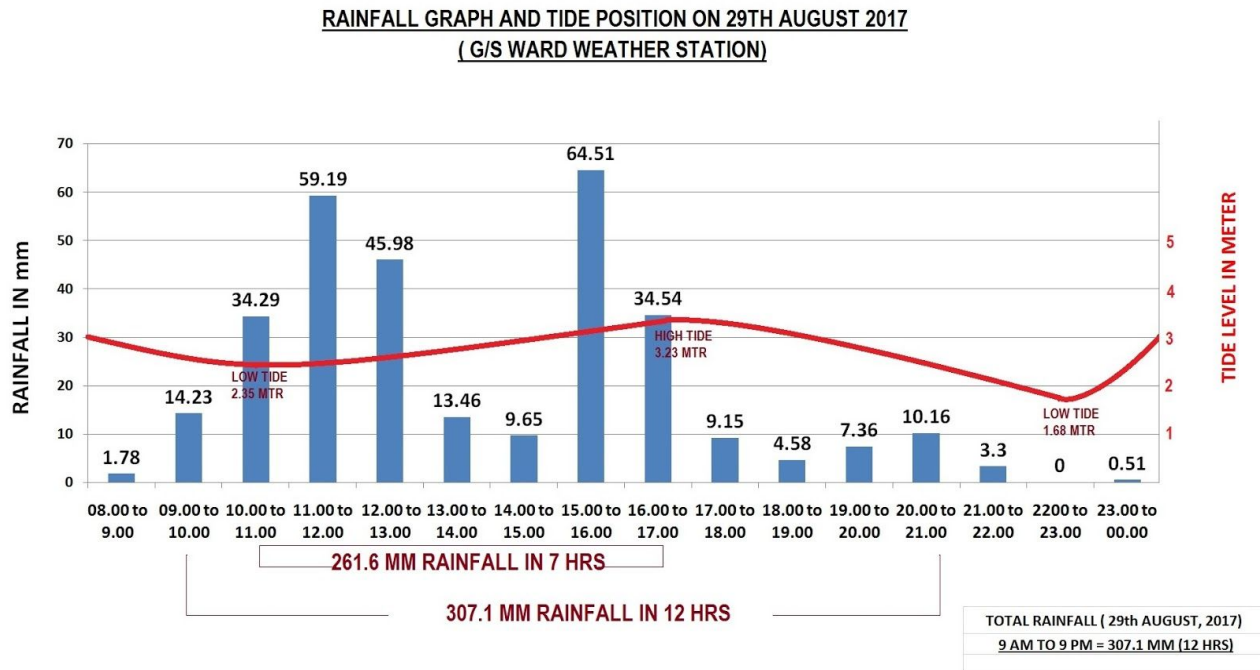
8.1.1 Neap tide effect

As explained in the report of the DMP mentioned above, the heavy rainfall intensity coupled with the Neap tide caused prolonged and heavy flooding in most part of the city ward. The difference in the low tide and high tide was very less and hence the discharge of the stormwater in the sea was very slow. The gates of Storm Water Pumping Station at Cleveland were operated accordingly keeping in view the neap tide effect. The graphical representation of the rainfall and tide levels on 29/08/2017 below shows the relation of intensity of rainfall and the tide levels and how it had affected the receding of storm water drain in G/South Ward’s jurisdiction.

It is observed that on 29/08/2017, there was extremely heavy rainfall in Mumbai, in general, and the surrounding area of G/South Ward jurisdiction, in particular. There was neap tide due to which the difference in low and high tide level was only 0.88 mtrs leading to substantial flooding. The graphical representation of the tide levels and rainfall on 29/08/2017 shows this clearly as described in above paragraph at 8.1.1. The gates of the Cleaveland Storm Water Pumping Station could not be opened for almost 14.50 hours due to the neap tide effect which delayed discharge of the stormwater in G/South Ward.

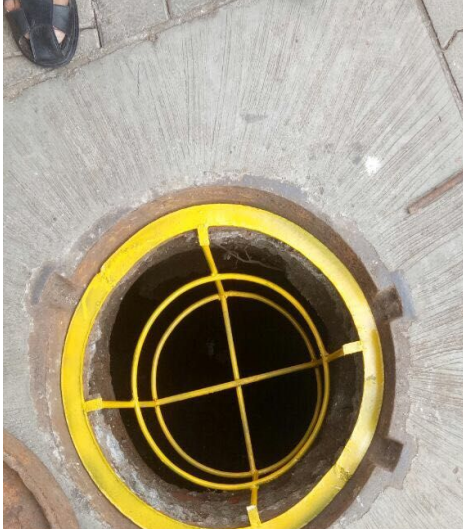
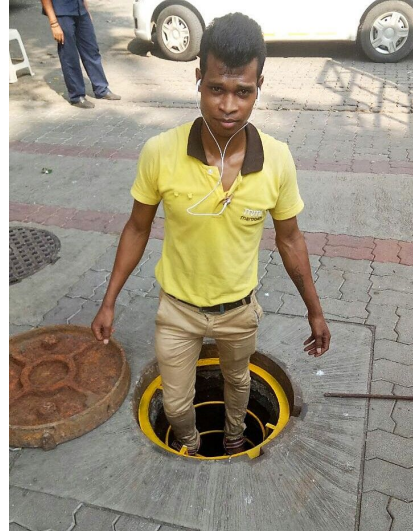
10.1.3.1 There is a suggestion from Shri. Ketan Kadam about the use of a bucket shaped metal frame to be fixed in the manhole just below the manhole cover so that water will be allowed to pass smoothly, but will prevent fall of any person in the manhole. The suggestion needs to be studied and verified by the SWD and SO department about its usefulness and practicability. The photographs of the suggested mechanism are at next page.

Above options shall be studied and viable/doable option shall be put forth / implemented by concerned departments.

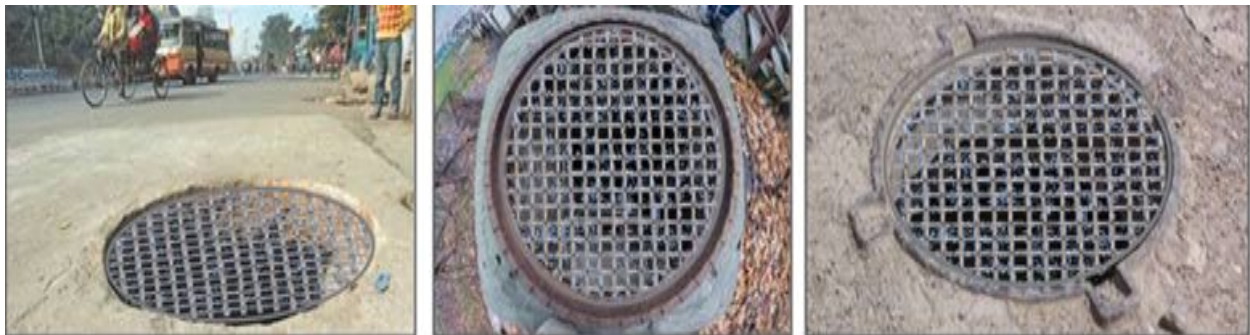
10.1.3.2 Wire mesh over the manhole/grated cover over the manhole

There is a suggestion by Shri Jatin Khandwala, seen on facebook which suggest putting a wiremesh type of cover on the manholes. This also needs to be studied by the concerned department from safety point of view taking into consideration the heavy vehicular load that it is supposed to withstand. The photographs of the same are as below.
